## **Contemporary Study On Road Safety In Urban Areas- A Case Study From Bwssb Office To Ms Palya**

*The road selected for this particular study fall under the similar issues faced by areas of Bangalore city like Silk board junction, Hebbal junction, and KR Puram junction. The selected road stretch has no traffic signals, even with the presents of too many junctions in frequent intervals. More number of Educational Institutions, International Airport Commuters and many other in Yelahanka cause dense traffic congestion in the selected path. To ensure the complete safety of the road users the provided road inventories such as median, pedestrians' path, carriageway, curbs and other road inventories should be in standard measurements as per the government regulations. The speed breakers, barricades, signal systems, road margins, cross slopes and the shoulders which are the integral part of the road should be given attention in order to prevent unforeseen incidents. The potholes, absence of sign boards in turnings and marking on speed breakers would raise the chances of accidents.*

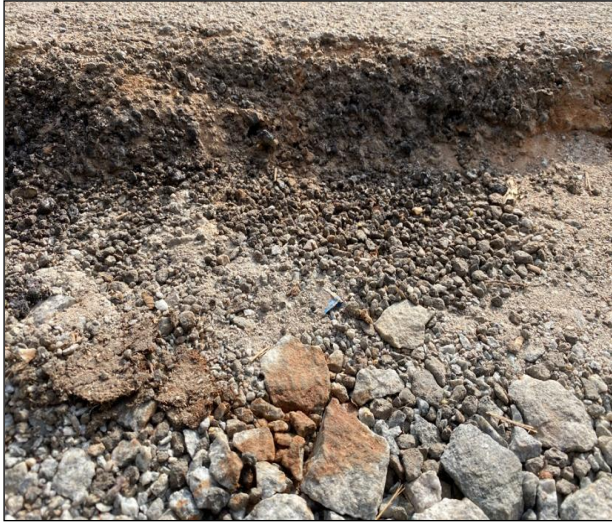
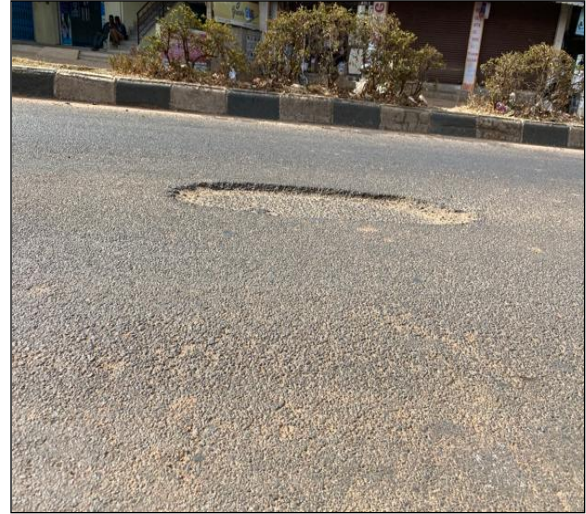
**Figure 3: Photos of Slight pavement edge drop and Formation of Ruts**

- 1) Along the stretch, the geometric feature of the road does not meet the design standards and it is necessary to make sure the design standards are satisfied. Non-periodic maintenance of the roads has caused formation of pot-holes, ruts, raveling, etc. In order to prevent these from happening periodic maintenance of road to be carried out.

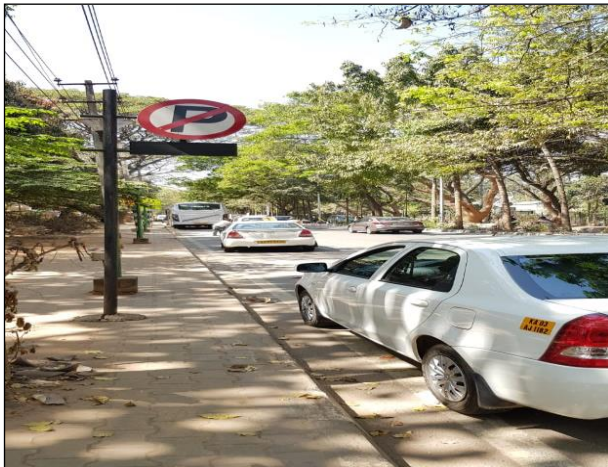
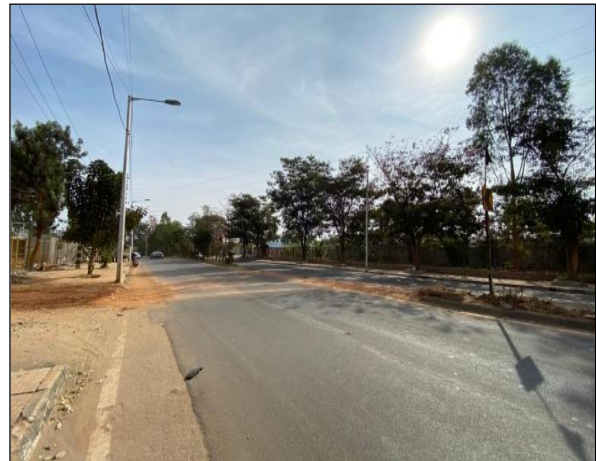
**Figure 4: Photos of improper parking activities and no proper median**

- 3) Conducting the Traffic Volume study gives the gist of traffic flow in the stretch. Illegal movement of vehicles can be avoided through proper sign boards and barriers. One-way roads can be provided at areas where there are illegal crossings and also during peak-hour traffic alternative routes can be provided to reduce the traffic density.

- 4) The footpaths are not provided at many locations and misuse footpaths for throwing away garbage has been observed in strength. Ease of movement for the pedestrians can be fulfilled by designing the footpaths to the geometric standards and also providing pedestrian crossings, signals at junctions.

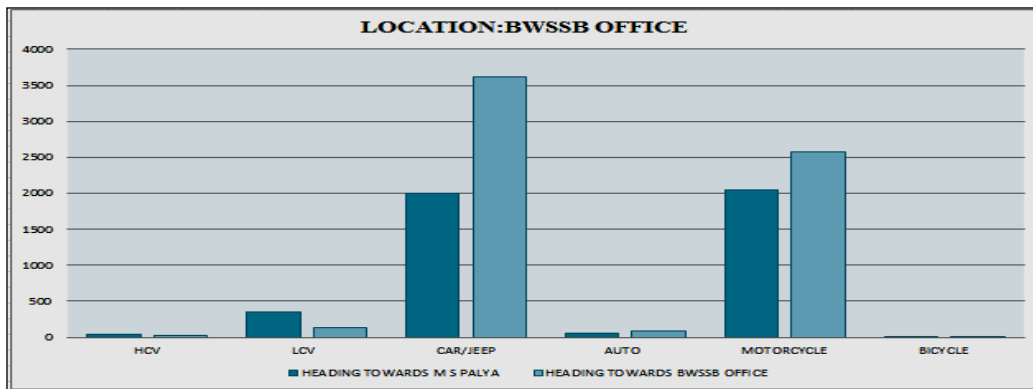
**Figure 5: Volume count difference between direction heading towards MS Palya signal and BWSSB Office at the location BWSSB office.**

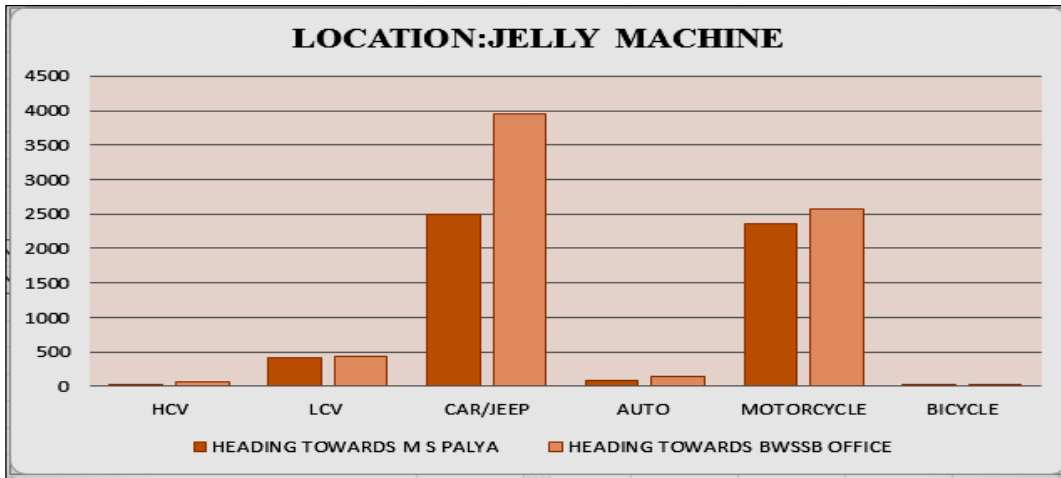
**Figure 6: Volume count difference between direction heading towards MS Palya signal and BWSSB Office at the location Jelly Machine.**

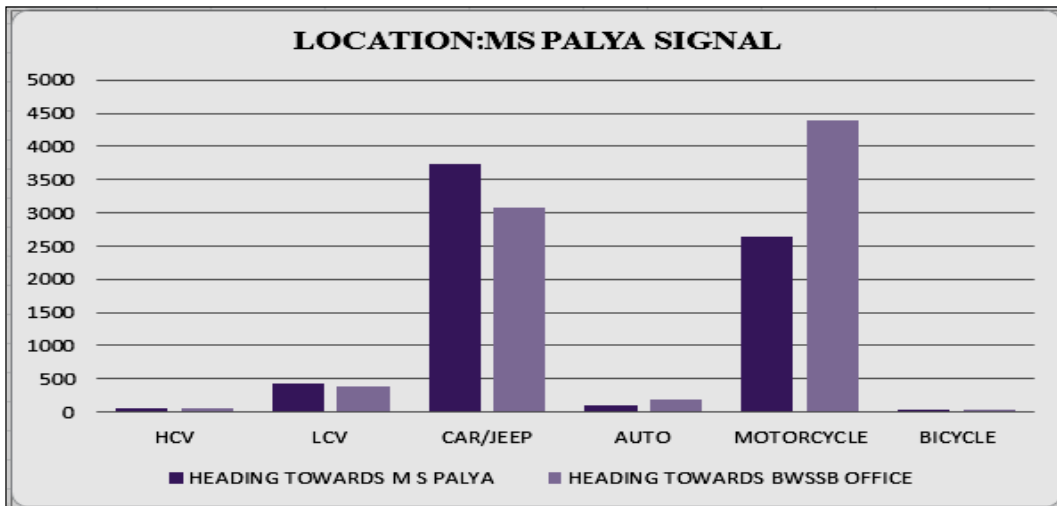
**Figure 7: Volume count difference between direction heading towards MS Palya signal and BWSSB Office at the location MS Palya signal**

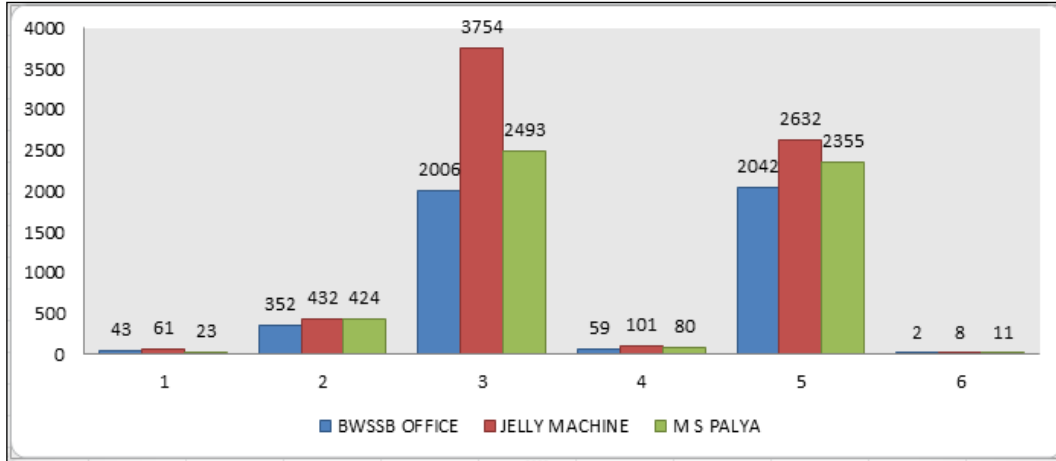
**Figure 8: Difference in morning peak hours**

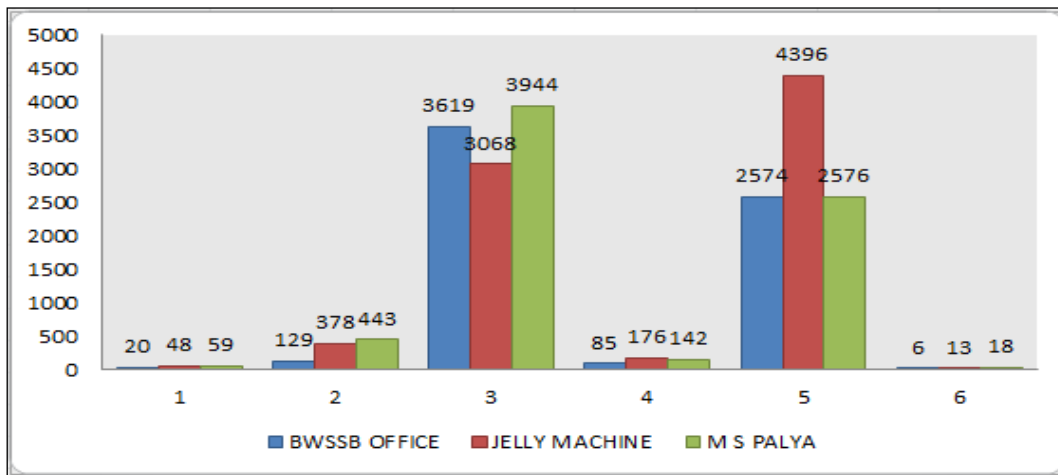
**Figure 9: Difference in evening peak hours**

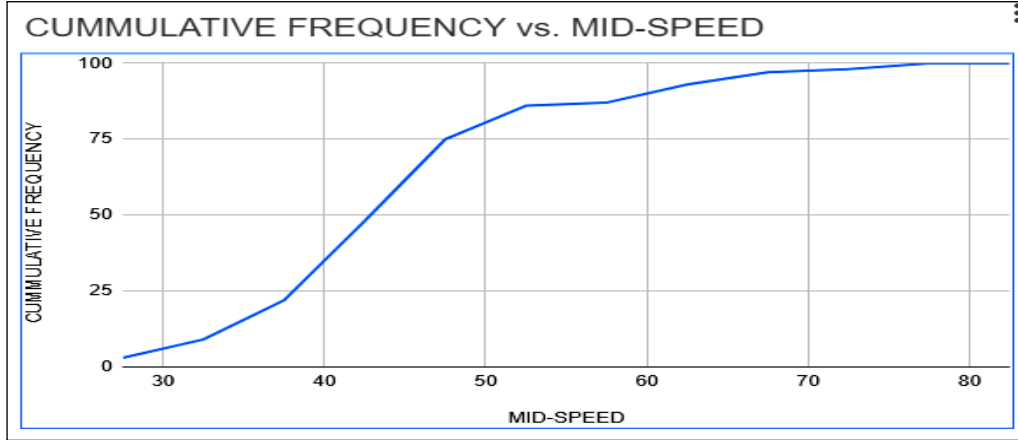
**Graph 1: Shows the 85th percentile of speed of vehicle at the region**

**Time mean speed=46.65 kmph**

**Space mean speed=44.78 kmph**

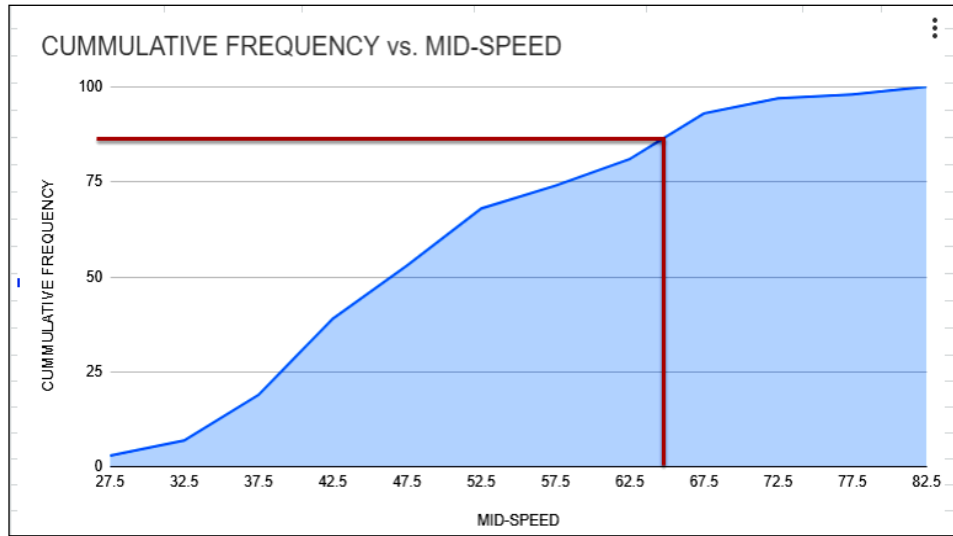
**Graph 2: Shows the 85th percentile of speed of vehicle at the region**

**Time mean speed=50.9 kmph**

**Space mean speed=47.96 kmph**
