Recovering of Cracks in Concrete to Enhance Its Strength by *Bacillus licheniformis* - A Biomineralization Study

Oshin Victor¹, *Freeda Christy C², Kavitha S³ and Padmanabhan D⁴

Karunya Institute of Technology and Sciences, Coimbatore 641 114, Tamil Nadu, India

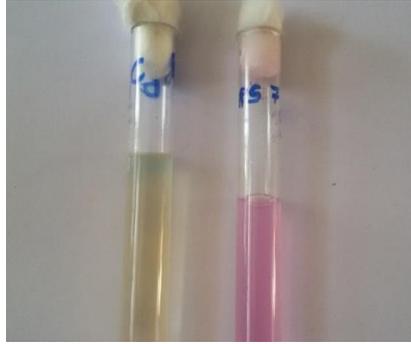
Fig. 1 Colour changes to Pink

The colour changes from light orange to pink, because of the change in the alkaline medium (ie) pH value, as ammonia changes the medium basic and the ammonia formation by urealytic activity was indicated in the reaction (1, 2). This indicates that the bacteria, *Bacillus licheniformis* can be survived in the alkaline environment as the concrete is alkaline.

The microbial induced calcium precipitation (MICCP) by urealytic bacteria was carried out to study the calcium carbonate precipitation to recover the cracks in concrete. Also in-vitro test for calcium carbonate precipitation in cement mortar was studied. Then the bio –concrete was studied for the improvement of the mechanical properties of concrete. The bacteria was isolated, cultivated and its survival in alkaline medium was made by urease test method as concrete is in alkaline medium with pH value 13. Urease test was carried out by preparing urea broth by adding 20gms/l of urea with 5gms/l of NaCl, 2 gms/l of mono Potassium phosphate, 1gm/l of peptone and Dextrose, 0.012 gm/l of Phenol red and 150 gms/l of agar. A loop full of *Bacillus licheniformis* was inoculated into the urea broth and incubated at 37°C for 24-48 hrs. Obtained the broths from the incubator and observed the colour change as indicated in Fig 1.

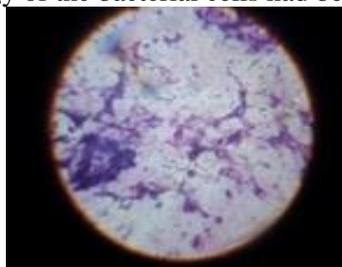
Fig. 2 Crystal Violet in the cell wall indicates Gram-Staining Positive

The crystal violet and iodine form an insoluble complex that is bound to the thick layer of peptidoglycan of Gram positive bacteria that appears blue or dark purple in colour. This thick wall gets dehydrated as it undergoes decolourization and the cell pores are closed as it shrinks which prevents the stain to move out

from the cell. As the bacteria *Bacillus licheniformis* showed Gram positive staining indicated the thick walled peptidoglycan which preserves the cell walls of the bacteria and its shape in the alkaline concrete. Then the study was carried out for bio-mineralisation process which influences the CaCO_3 crystal formation and the ureolytic activity are greatly affected with calcium concentrations, pH value and dissolved inorganic carbon concentrations. The bio minerals are formed by the chemical process with the influence of urease [15]. These parameters impact the carbonate particles focus and constant calcium carbonate development [16]. Microbes fill in as nucleation destinations in the biomineralization processes, for precipitation of calcium carbonate with the microorganisms. These parameters incredibly influence either the ureolytic movement or CaCO_3 crystal formation. For the bacterial growth, the hydrogen ion concentration of an organism's environment plays the major role. It limits the fusing of bacterial enzymes which is responsible for synthesizing the new protoplasm. Since concrete is in highly alkaline condition, the bacteria identified should survive in the highly alkaline condition. So the identified bacteria, *Bacillus licheniformis* were grown in the nutrient agar of different pH range of 7 to 9 prepared in a conical flask and sterilized in an autoclave at 121°C for 15 minutes. Then, it was poured in the nutrient medium into 4 petri plates each with different pH as shown in Fig 3.

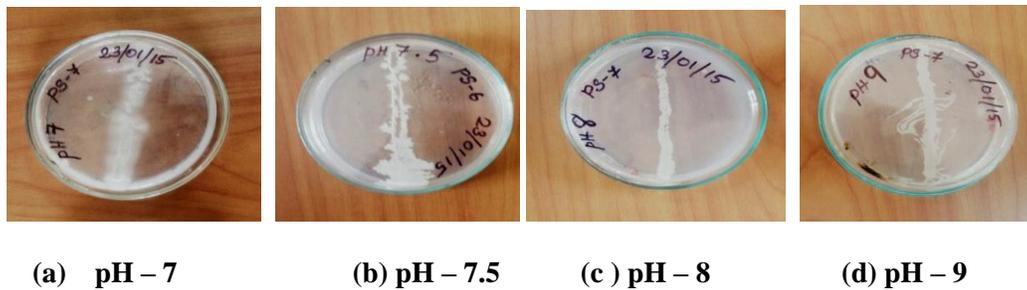
Fig. 3 (a) – (d) : *Bacillus licheniformis* survival at various pH

In the stir of cementing, the *Bacillus licheniformis* suspension was streaked into each petri plates and incubated at 37°C for 24hrs. From Fig.3, the development of microscopic organisms at different pH was observed. *Bacillus licheniformis* survived in the high alkaline condition. Hence, it may be very well utilized in the concrete to plug the cracks.

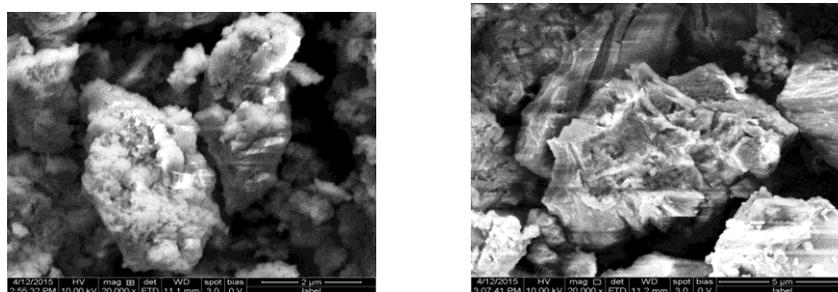
Fig. 4 SEM micrographs of different morphologies of calcite crystal precipitated

From Fig. 4, the SEM analysis with *Bacillus licheniformis* confirmed the presence of distinct calcite crystal precipitation in the bacterial samples which improves the bonding property in concrete. The presence of crystalline calcite associated with bacteria indicated that bacteria serve as nucleation sites during mineralization process [17]. The calcium carbonate precipitation of bacteria in the bio concrete was studied in cement mortar by In-vitro method. Cement mortar samples were prepared with aggregate to cement ratio as 2:1 with 0.5 water to cement ratio. These concrete mixture is prepared in a petri plate and kept for drying. It is taken as control specimen. Concrete mixtures with different bacterial concentrations were then prepared in different petri plates with bacterial culture added to the water content. Cracks were created manually on the semi set cement mortar. Then the cement mortar was dried at room temperature and observed the crack healing capacity under microscope after incubating the cement mortar for 7 days. The microbial induced calcite carbonate precipitation was formed as shown in Fig. 5.

In order to recover the cracks in the concrete, the bacteria present in the concrete should be able to convert the soluble organic nutrients into insoluble inorganic calcite crystals which seals the cracks [9]. Calcium carbonate precipitation test were carried out by preparing controlled B4 medium for mineral precipitation with 60 gms/l of calcium acetate, 12 gms/l of yeast extract and 12 gms/l of glucose. Later the bacterial sample were grown aerobically in 50 ml of modified B4 medium with bacterial inoculums. All bacterial stains were incubated at 30°C up to 3 weeks. The precipitated carbonates were collected on Whattmann No.1 filter paper by filtration, washed with sterile distilled water and air dried at 37°C . The crystals precipitated were collected and the amount of carbonate crystals precipitated by different isolates were estimated. Microstructure analysis of the precipitated carbonate crystals was carried out by SEM as shown in Fig 4.

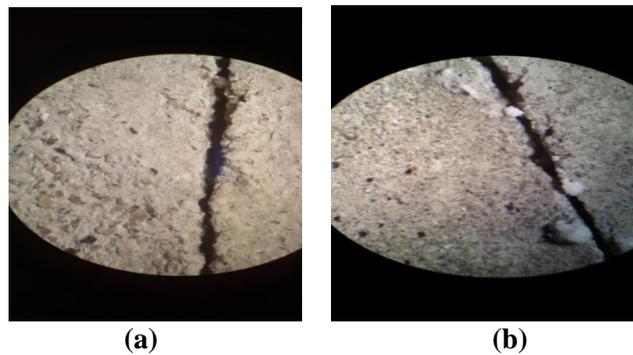
**Fig. 5 (a) Crack in cement mortar
 (b)CaCO₃ precipitation in cement mortar**

Bacteria on fresh crack surfaces become activated due to water ingress, start to multiply and precipitate minerals such as calcite (CaCO₃) which eventually sealed the crack. With the identified bacteria, the bio-concrete was prepared with the M20 mix. Two sets of samples were prepared as one set of concrete with bacteria as bioconcrete, the test mix and the other set of concrete without bacteria as the control mix. The identified bacteria, *Bacillus licheniformis* along with the calcium-based nutrient known as calcium lactate in 5%, 10%, 15% as nutrient were added to the ingredients of the concrete at the mixing stage of the fresh concrete as shown in Figure 6, 7 and 8. The bacteria that was mixed to the concrete involves two mechanisms, bacteria acts as a catalyst and calcium lactate i.e. the mineral precursor converts it to calcium carbonate minerals as indicated in reaction (3).

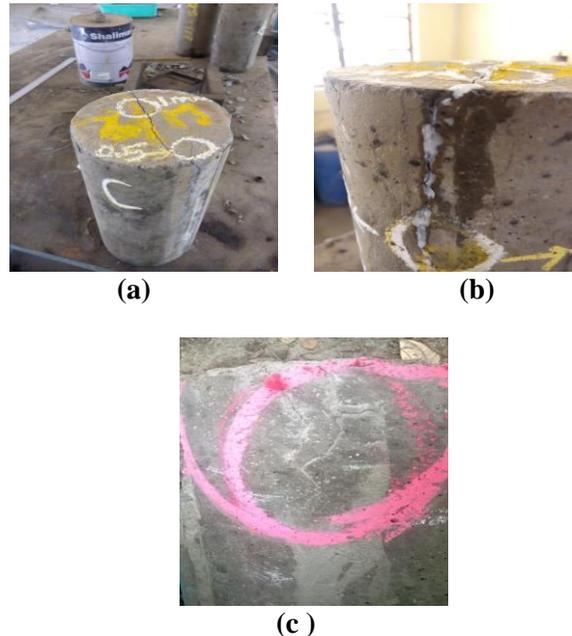
Fig. 8 Recovery of crack in concrete

(a) Crack in the concrete
(b) Calcium carbonate formation
(c) Cracks filled in by *Bacillus licheniformis* precipitation

Concrete, an alkaline material with pH as high as 13. This alkalinity imparts concrete the protection against corrosion. Since *Bacillus licheniformis* survived in high alkaline environment, study was carried out on bioconcrete and with the addition of the bacteria *Bacillus licheniformis* along with calcium lactate as nutrients by 5%, 10% and 15% weight of cement at the stage of preparation of the concrete by mixing the spore suspension in concrete mixing water for microbial activities to form inorganic solids as indicated in Fig 8 (a). As the crack appears in the concrete, water enters through the crack it activates the dormant (inactive) bacteria *Bacillus licheniformis* by the process of metabolically mediated calcium carbonate precipitation and it recovers the concrete cracks. Calcium hydroxide being soluble in nature dissolves in excess water and comes out from cracks as leaching, indicated in Fig 8 (b). The cracks were plugged because by *Bacillus licheniformis* in concrete and it was healed as indicated in Fig. 8 (c). A biological approach of self-recovery in concrete is one such crack remediation methods in which bacteria *Bacillus licheniformis* induce bio-minerals during their growth and metabolism and fills the cracks and pores in the concrete.

In self-recovering concrete, active metabolic conversion of calcium nutrients takes place with *Bacillus licheniformis* in the presence of moisture content and the crack width was reduced from 0.3mm to 0.05mm. The cracks were plugged in the concrete to about 83%. This 'self-recovering' property brings about water tightness and thus restricts the infiltration of destructive substances into concrete structures and improves the concrete durability. Then the flexural strength of the concrete was studied as it plays a major role in the structural design of pavement concrete. The flexural strength is referred as the modulus of rupture of the concrete. Modulus of rupture were performed on 100 x 100 x 500mm prisms as per ASTM C 78 [18] as shown in Fig.10

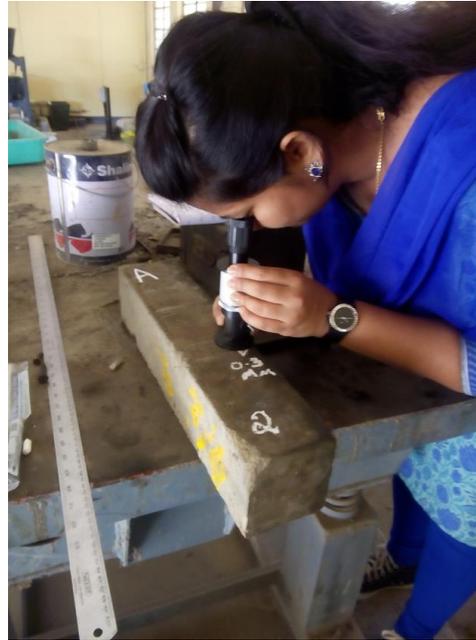
Initially the crack width was measured using micrometer and the crack width was observed as 0.3 mm as shown in Fig. 9

Fig. 9 Crack width measuring using micrometer

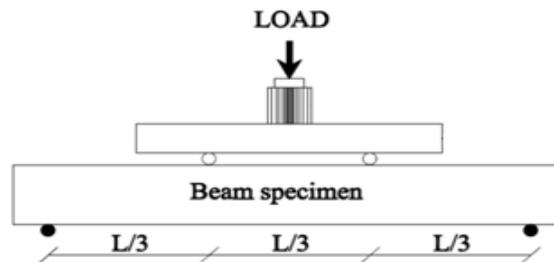
Fig. 10 Flexural testing

Concrete specimens for beams were cast with M₂₀ grade concrete with w/c ratio of 0.50. The bacteria *Bacillus licheniformis*, with calcium lactate were added as 5%, 10% and 15% as nutrient in the M₂₀ concrete mix. The modulus of rupture of concrete were determined by third-point loading in the flexural testing method and the results were indicated in Table 1.

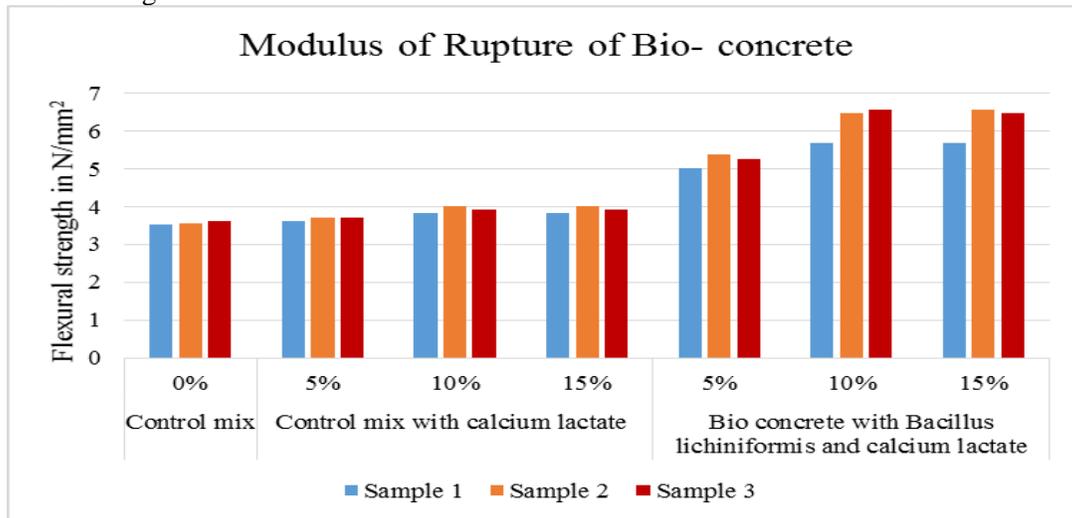
Fig. 11 Modulus of Rupture of Bio concrete

It was observed from the Fig.11 that the cracks were plugged through bio-mineralization and the flexural strength of the concrete was increased twice with the addition of 10% and 15% of *Bacillus licheniformis* in the concrete. The *B. licheniformis* increased the flexural strength of about 48% in this study whereas in the study conducted by Anandasu et al [19] the tensile strength of bio concrete using *B. subtilis* increased 38.17% and *B. sphaericus* increased 31.14%. Stronger physical bond between the rough-textured aggregate and the cement paste is responsible for the increased tensile strength [20]. The ecofriendly nature of bio concrete may be used in construction industries.

From Table 1, as the internal cracks occurred, the bacteria became activated and precipitate calcium carbonate and plugs the cracks which enhanced the flexural strength of the bioconcrete. The Modulus of Rupture of the concrete and the bioconcrete with the bacteria '*Bacillus licheniformis*' were determined and indicated in Fig. 11.
